# **BROWNFIELDS CLEANUP COOPERATIVE AGREEMENT WORK PLAN**

Submitted by:  
**Lifecycle Building Center  
1116 Murphy Avenue SW, Atlanta, GA 30310**

**DRAFT UPDATED ANALYSIS OF  
BROWNFIELD CLEANUP  
ALTERNATIVES REPORT**

**LIFECYCLE BUILDING CENTER SITE  
1166 MURPHY AVENUE SW ATLANTA,  
GEORGIA 30310**

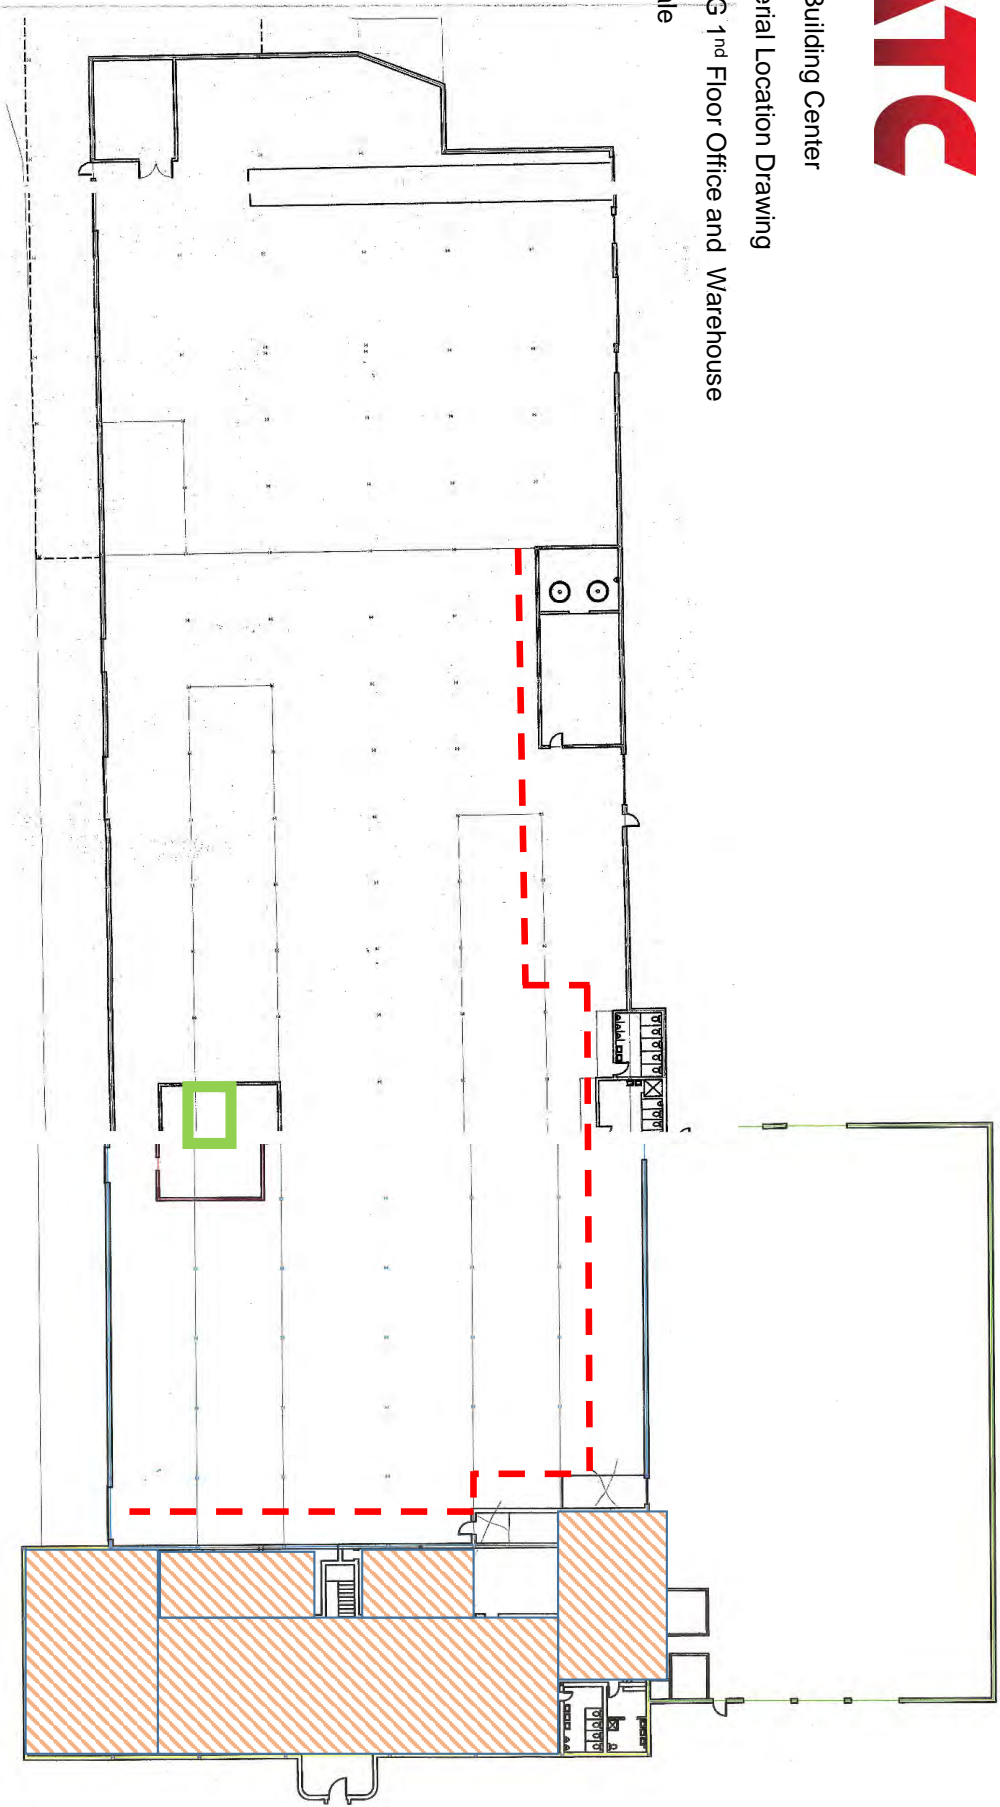
Various ACM Flooring(s)

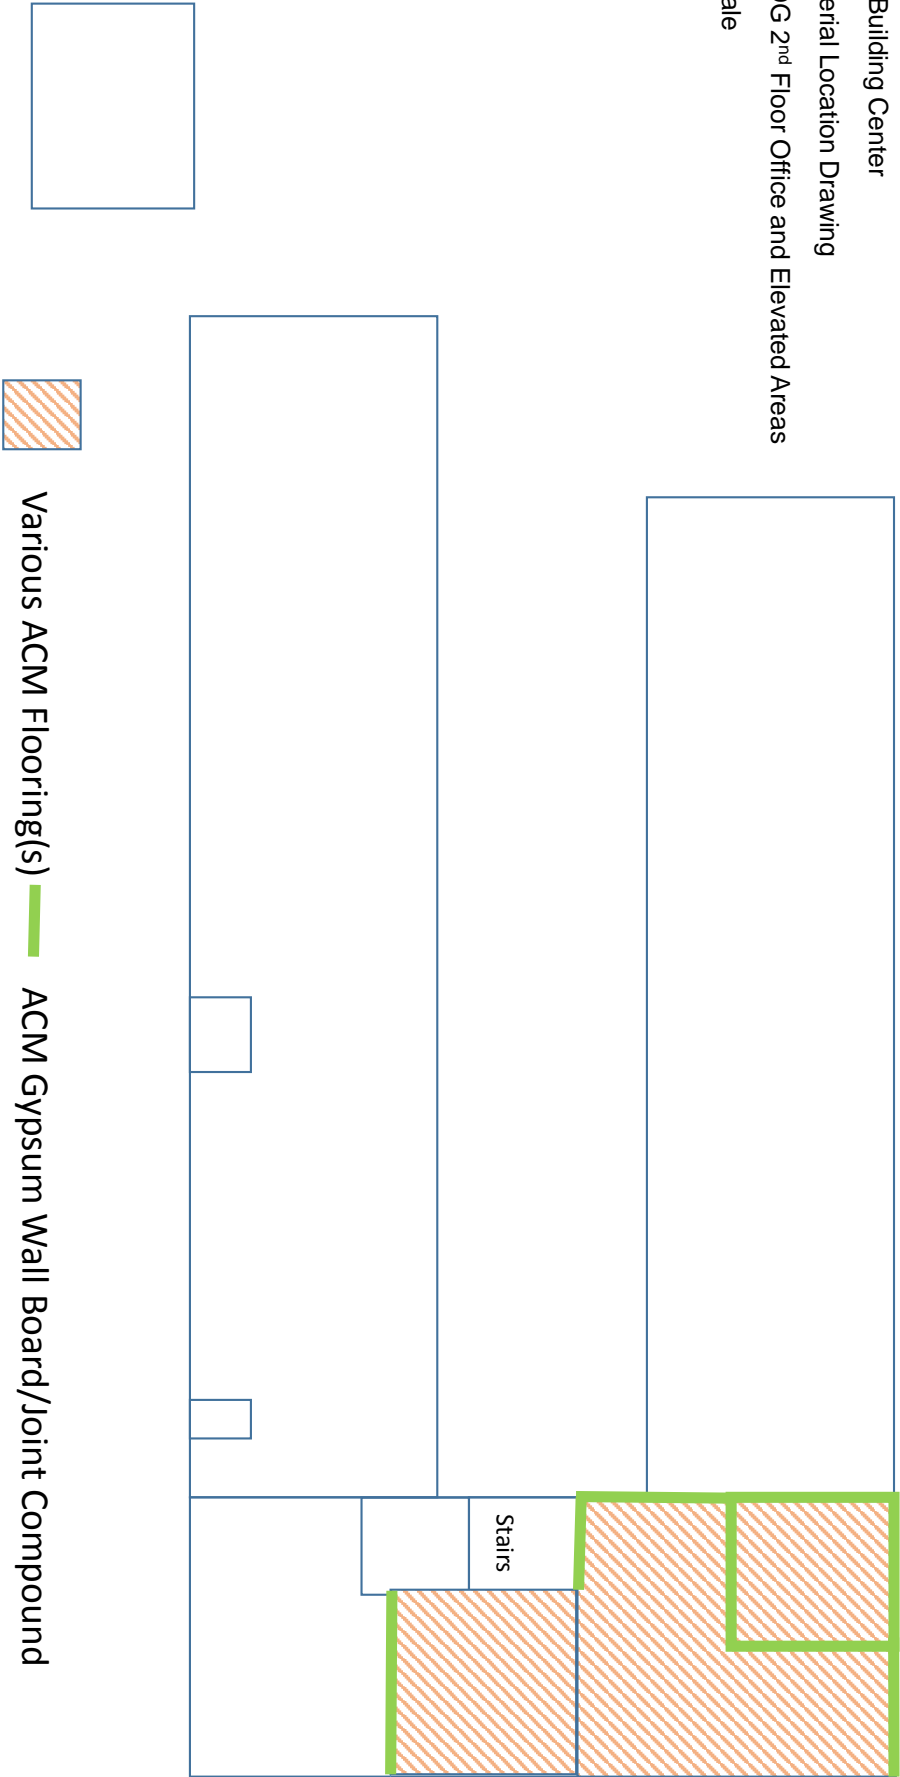
ACM Corrugated Panels on roof and exterior walls not shown

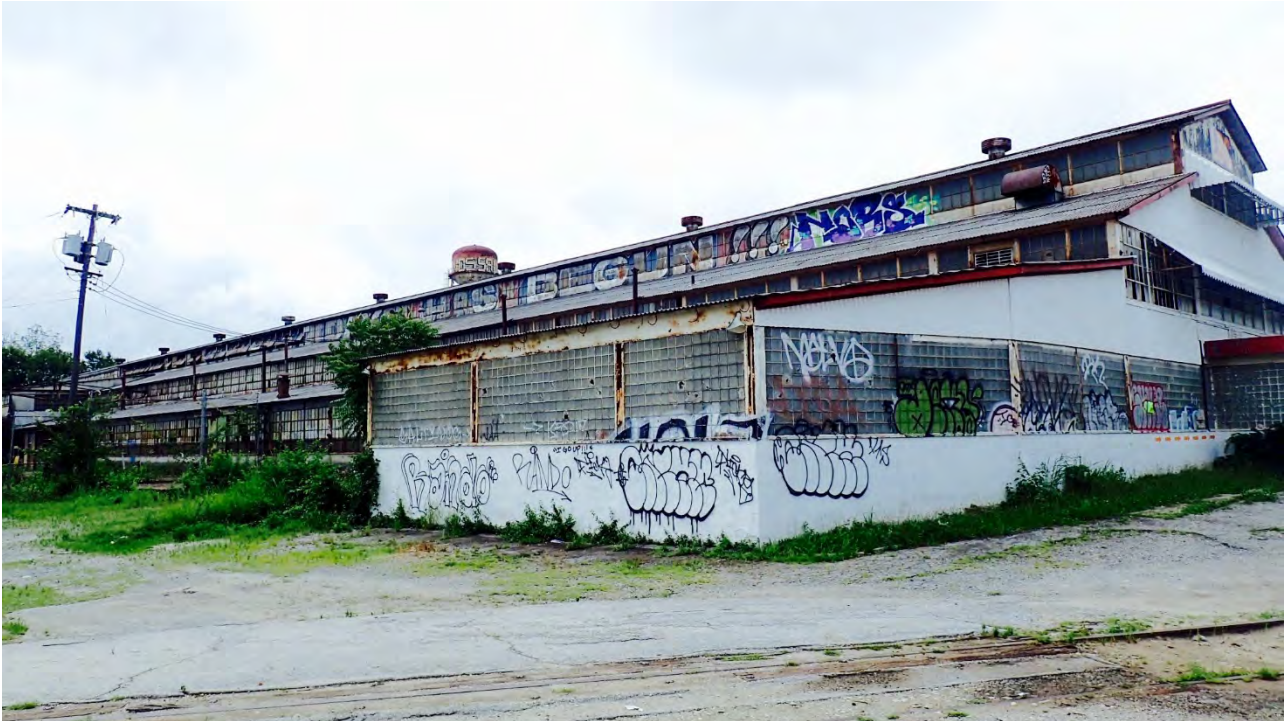
**Area of soil excavation along the north side of the Lifecycle Building Center. Notice the proximity of the decommissioned CSX rail spur. This is the future BeltLine Westside Trail spur.**

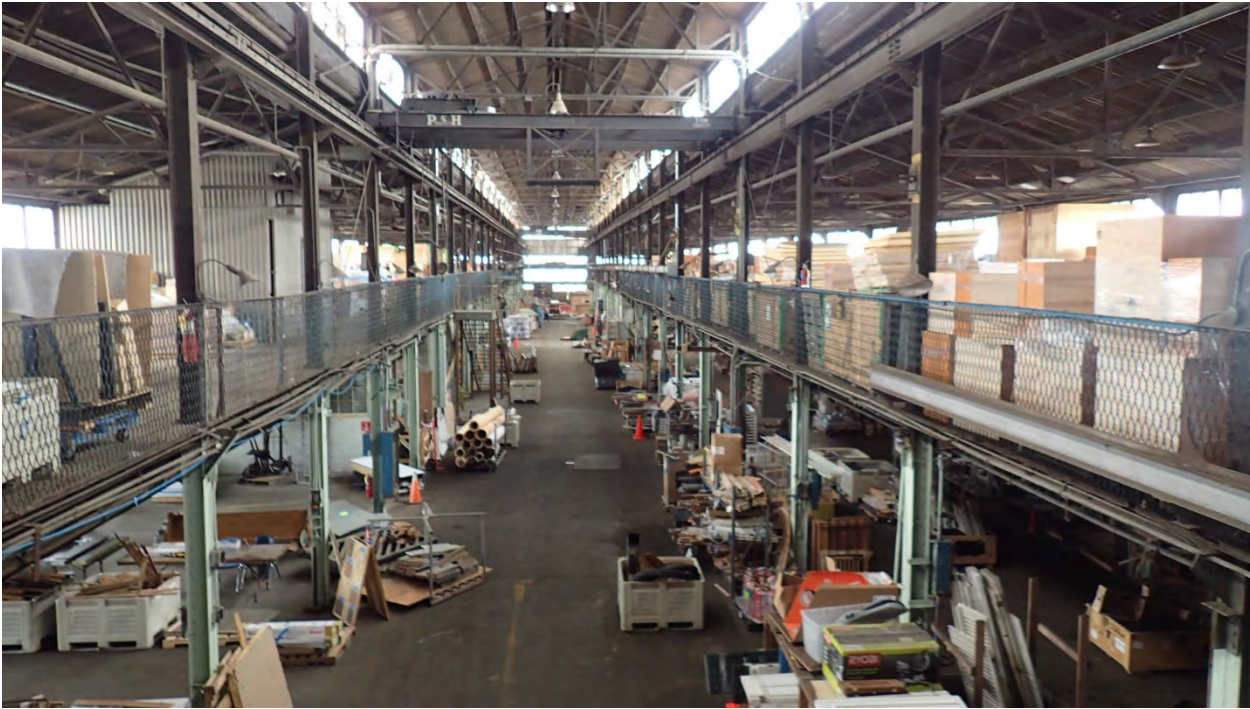
**View of LBC warehouse with areas containing asbestos containing materials (pipe wrap and corrugated Transite) and lead paint pictured along with retail.**

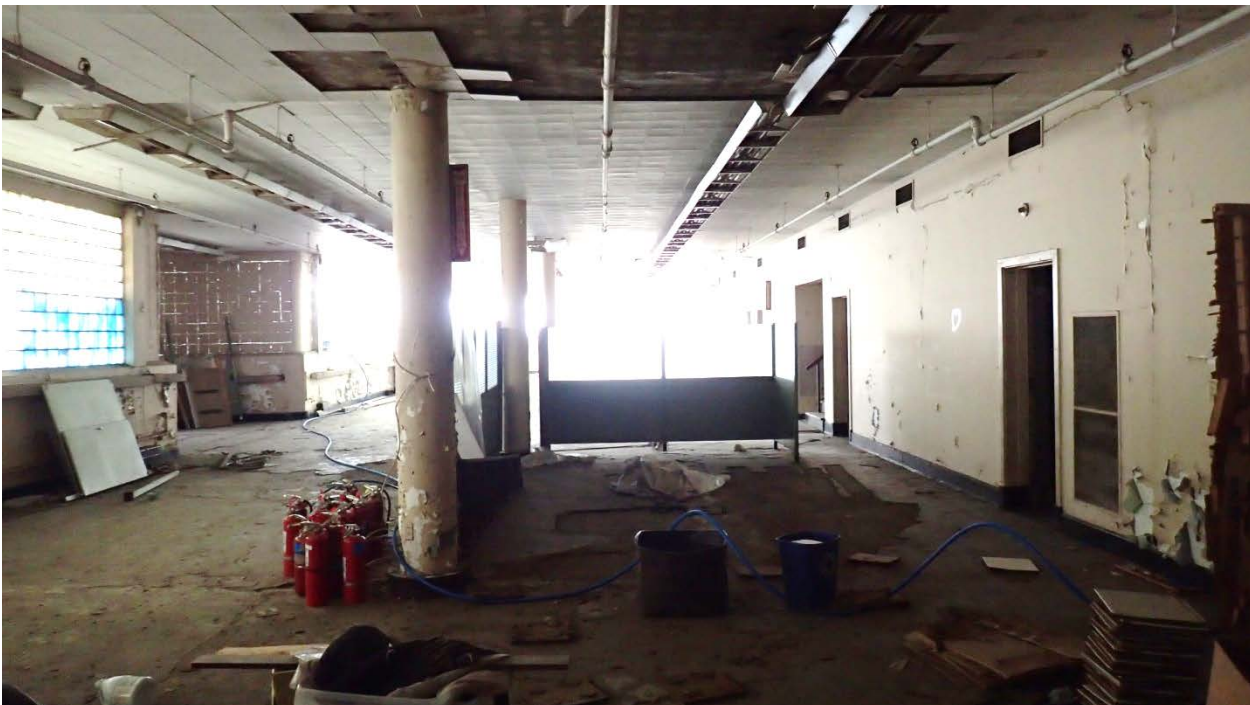
**LBC unusable front offices with asbestos containing materials (floor tiles and gypsum board and mastic)**

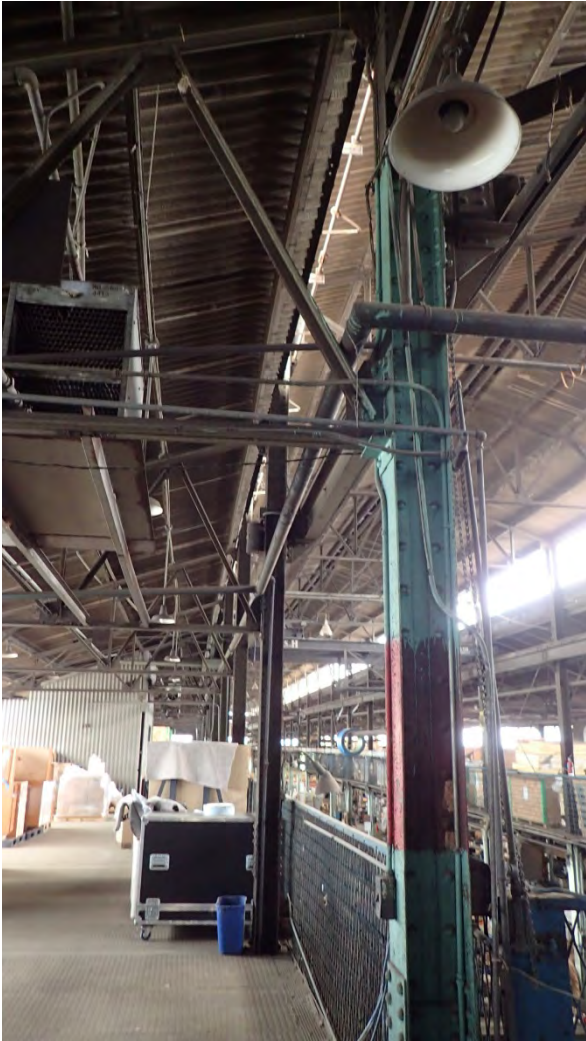
**LBC mezzanine level with asbestos containing materials (corrugated Transite) and lead paint pictured**

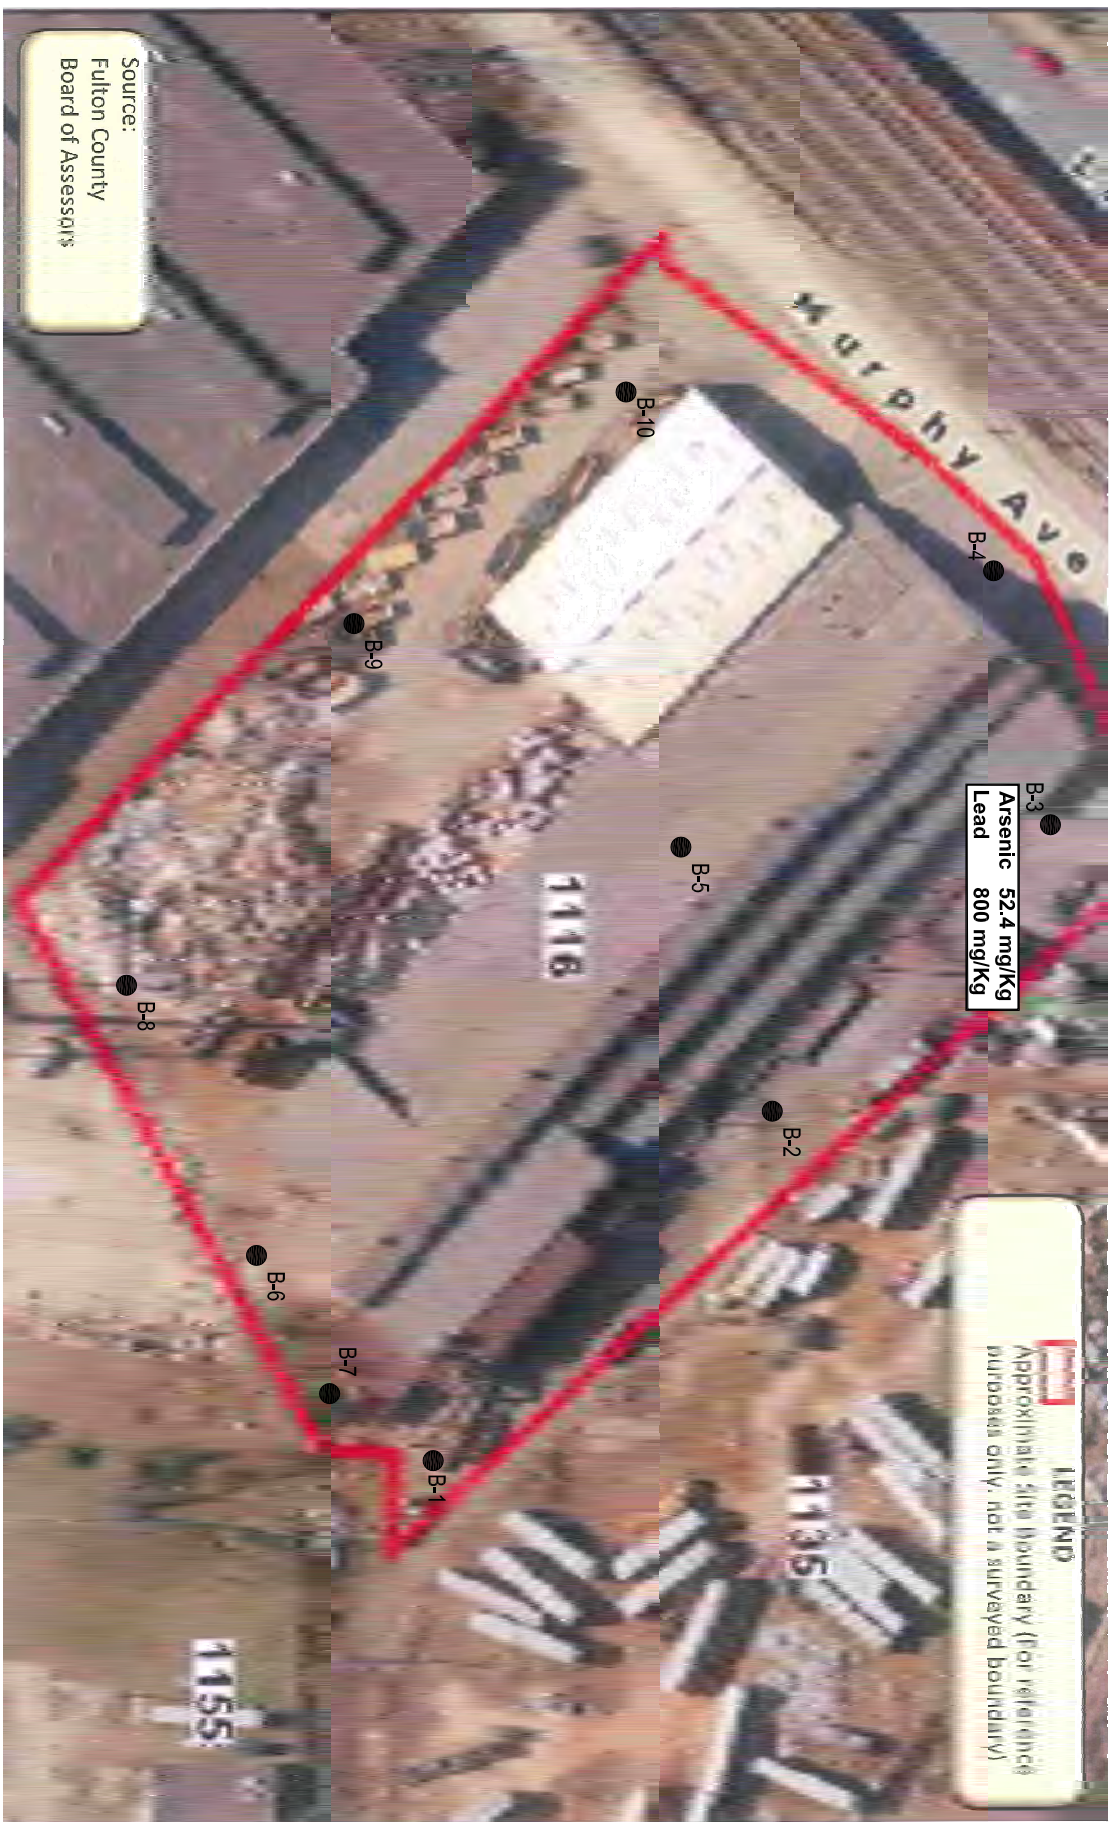
FIGURE: 3	
DRAWN BY:	ED
CHKD BY:	JK
DATE:	SEPT 2015
REFERENCE:

SOIL ANALYTICAL RESULTS

The detected soil concentrations exceeding HSRA Soil trigger notification values are presented on **Figure 3 of Appendix A**. **Appendix D** presents the results for VOCs in **Table 1**, the results for the 8 RCRA metals in **Table 2**, and the results for SVOCs are in **Table 3**. The results for PCBs are presented in **Table 4 of Appendix D**.
